Intel® Server Board SE7501HG2

Specification Update

Intel Order Number: C37940-001

August, 2004

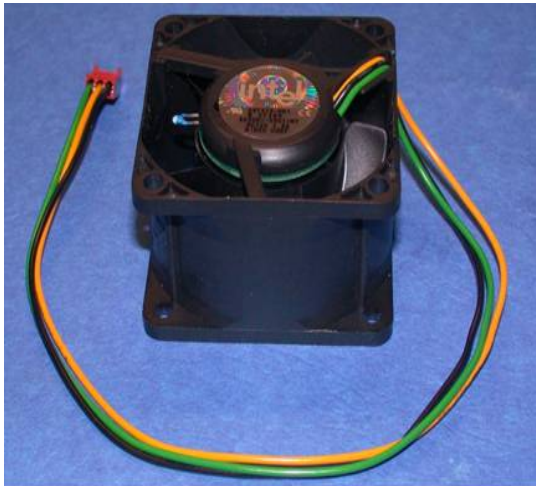
Figure 1. 38mm Fan w/1.5A requirement

Boxed Intel Xeon® Processors at and above 3GHz use larger fans, i.e., 38mm, than the 25mm fans used in 2.8GHz and below solutions. These fans being much bigger require more current draw, i.e., 1.5A versus the 340mA required for the 25mm fan. Older SE7501HG2 baseboards (eg., PBA A95718-303) cannot support this “extra” current requirement. An easy workaround is to draw this required extra current directly from the power supply. A fan cable adapter with tachometer sense (Part #:FW04B58-DN, Supplier Foxconn, Katie.Wang@foxconn.com) solution has been proposed that accomplishes this in a rather simple fashion.
