IBM 2130-xRX PCNS redundand installation problem

This document informs you on how to upgrade the UPS firmware code to eliminate an installation issue with PowerChute Network Shutdown when two 2130-6RX or two 2130-8RX are to be configured for failover.

Affected units

- IBM UPS 7500XHV, 2130-6RX
- IBM UPS 10000XHV, 2130-8RX

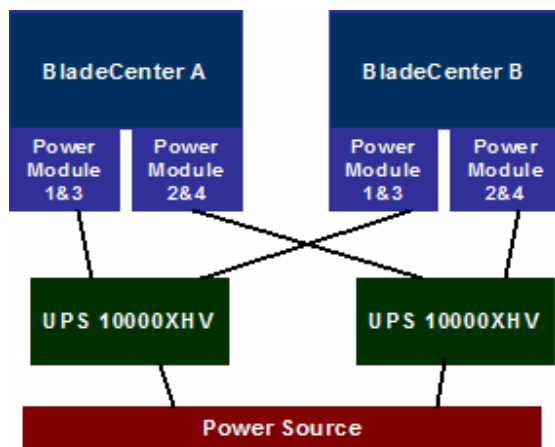
Two Bladecenters are connected to two redundant UPS 10000XHV for providing redundant power. Power supply to both Bladecenters can be maintained even if one of two UPSes should fail.
