# Intel<sup>®</sup> Server RAID Controller U3-1 (SRCU31)

Specification Update

Order Number: 273398-006

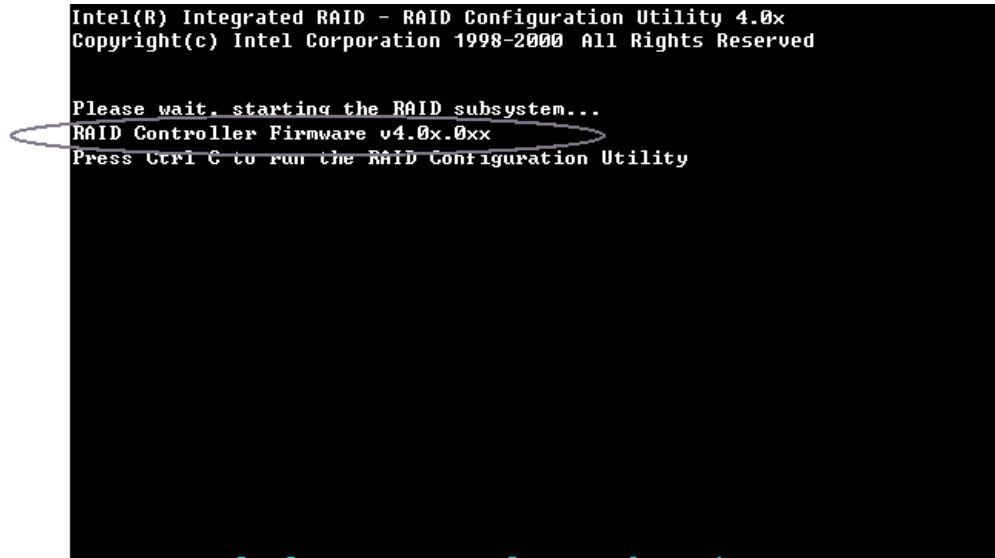
Figure 1. Firmware Version Displayed in the RCU

There are two methods for identifying the firmware version installed on the RAID adapter. While the system is booting, the RAID controller firmware initializes and displays the information shown in [Figure 2](#) to the screen. The firmware version is displayed next to the words “RAID Controller Firmware”.

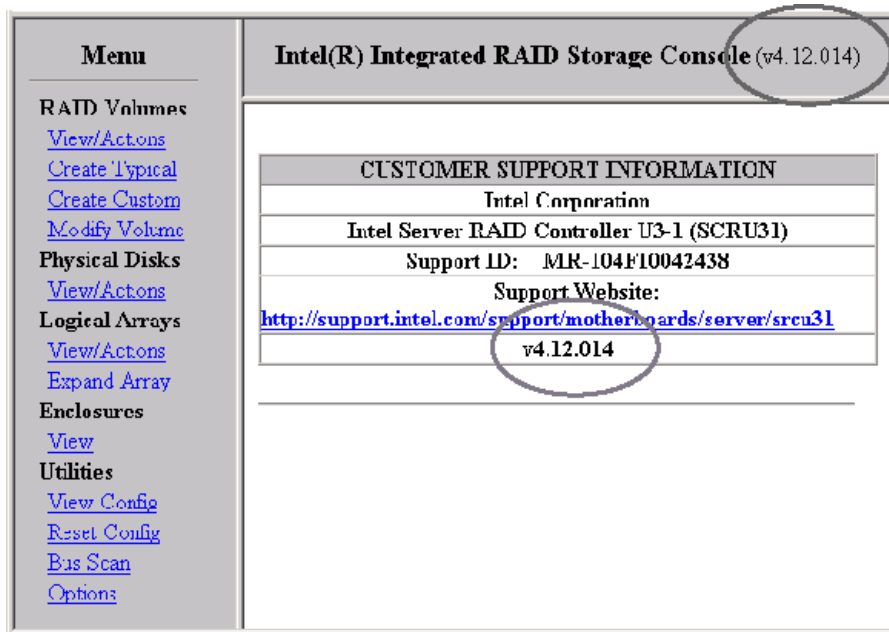
Figure 2. Firmware Version Displayed in Storage Console

An alternative method for identifying the adapter firmware version requires that the system be booted into the host operating system running the Storage Console application. With Storage Console running, select “Options” in the left frame and then “Support Info” in the right frame. The firmware version is listed in the table next to the words “Build Version”. See [Figure 2](#).
